**Flood Control Project Maintenance
Levee Inspections**

Maintenance Issue Types Only, Levee Inspection Report By Mile - Spring 2018

Sutter Maintenance Yard Maintenance Area 0013

Waterway	Bank	Unit Miles	Inspection Start/End	Inspector
Unit No. 01 Cherokee Canal	Right	18.19	04/17/2018 04/17/2018	Bob Duffey

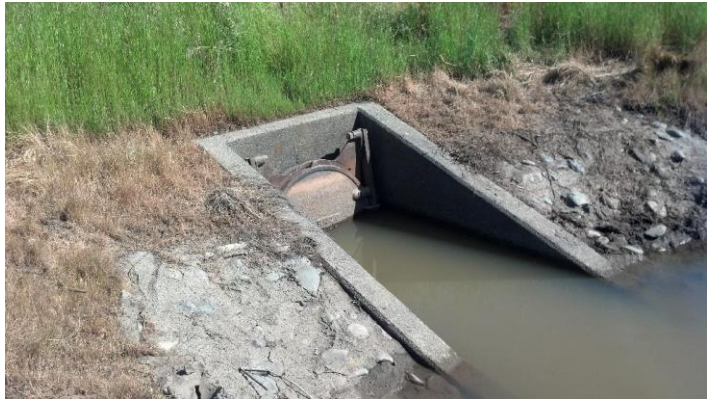
Photo 2 of 3 : UCIP_SP_2018_52123_67108.jpg

FS_ID:52123
DS_ID:16847
EP_NO: N/A
Repair Type: Non-Urgent
Crossing Status: Found
UCIP Comments: 6/5/2017 Both ends submerged but crossing appears to be in good condition. (DWR Sutter Yard-AFreitag)11/18/2016 Crossing appears to be in good condition. It appears that this crossing does not require a slide gate. (DWR Sutter Yard- AFreitag)4/27/2016 LS slide gate was still missing. Rest of crossing appears to be in good condition.7/01/2015 There appears to be a LS gate now but both pipe ends were submerged so it was hard to tell for certain.5/29/2014 Same as last inspection.12/9/2013 Pulled sticks from WS flap gate to allow it to close. Ls gate is still missing.7/10/2013 WS and LS slopes have been cleared of vegetation and are in good condition. LS gate is still missing and WS flap gate is still wedged open with sticks.4/19/2012 LS gate missing & limited inspection. Need photos of WS & LS cleared slopes. Description calls for slide gate on LS-slide gate missing. Debris scattered near LS headwall. This crossing was listed in the USACE Periodic Inspection report as Corp's Inspect ID# USACE_CESPK_M13J_2011_p_0010 for WS gate wedged open & missing LS slide gate.

Headwall and flap gate located on WS toe.

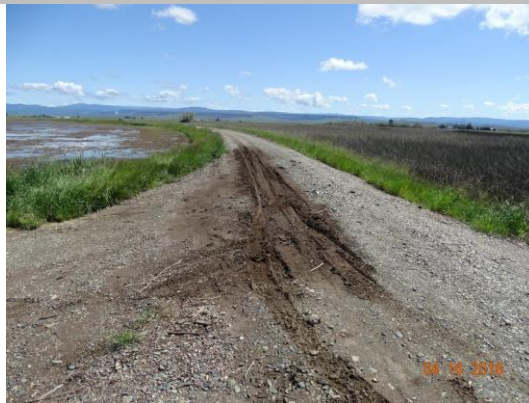
Photo 1 of 1 : SP_2018_MA0013_301_66_20180425_00136.jpg

LM Start	3.84	Rating **	M	Issue No.	66
LM End	3.84	Issue Type +	Ma	Location *	LS
Category	Earthen Levee			GPS Latitude/Longitude	
				Start	End
Item	Crown Surface / Depressions / Rutting			39.524467 °	39.524467 °
				-121.701878 °	-121.701878 °
DWR ID	DWR_MA0013_02_s_2018_66				
Comment Code					
C1 : Add appropriate material and re-grade the levee to bring the crown above the design elevation.					
Inspector Comment					
Repair the crown roadway.

View of the erosion on the crown roadway caused by flood water over topping.

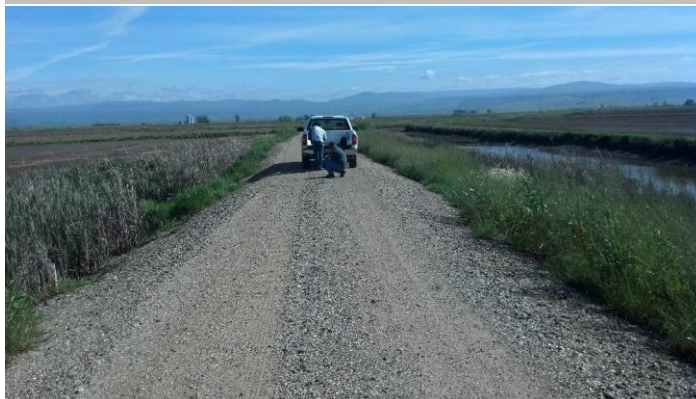
Photo 1 of 3 : UCIP_SP_2018_52124_67115.jpg

Overview looking east on right bank of Cottonwood

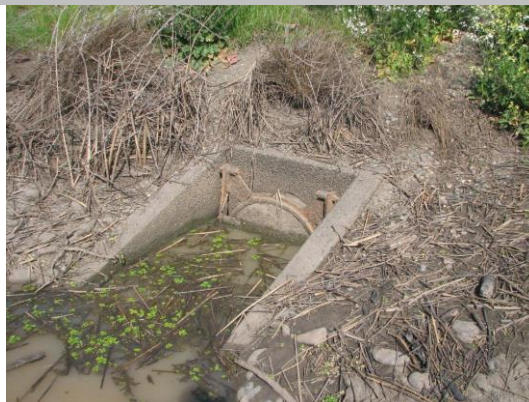
Photo 2 of 3 : UCIP_SP_2018_52124_67116.jpg

Unable to determine condition of flap gate on WS due to high water.

FS_ID:52124
DS_ID:16846
EP_NO: N/A
Repair Type: Non-Urgent
Crossing Status: Found
UCIP Comments: 6/5/2017 Both ends submerged during site visit. Pipe has been selected to be internally cleaned and inspected as part of the DMP project. (DWR Sutter Yard- A/Freitag)11/18/2016 Both pipe ends underwater for this inspection. (DWR Sutter Yard- A/Freitag)4/27/2016 Both pipe ends were underwater for inspection.7/01/2015 Both pipe ends and gates were fully submerged.5/29/2014 Same as last inspection.12/9/2013 Same as last inspection.7/10/2013 WS slope is cleared of vegetation and is in good condition. Both gates were fully submerged under water and unable to be inspected.4/19/2012 Rodent activity caused partial collapse on LS of levee in the vicinity of pipe. Limited inspection on WS slope due to dense vegetation. Limited inspection on gates due to both gates submerged under water.
FIELD_STRUCT_DESC: 36-inch corrugated metal drainage pipe through the levee, 9.3 feet below the crown. Flap gate on the waterside (WS) end. Slide gate on the landside (LS) end. Concrete "U" headwalls on both ends. Concrete sump area with flash boards to drain farmers field is located on farmer's property near drain inlet. [Additional Reference(s): DWR Levee Log, 1993. USACE Sacramento O&M Manual 519, June 1962 (HLM 4.20)]

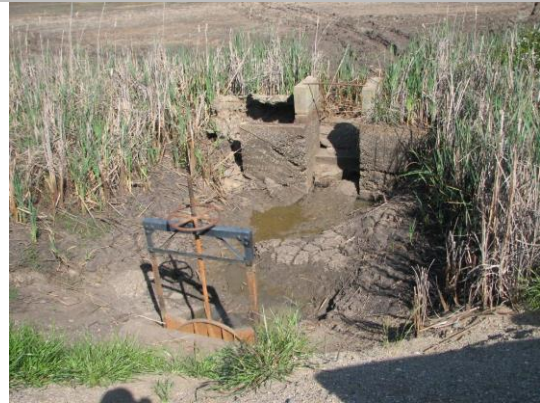
Photo 3 of 3 : UCIP_SP_2018_52124_67113.jpg

Overview of LS screw gate and concrete sump structure.

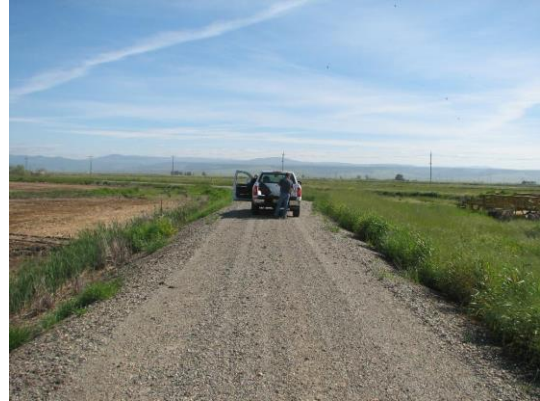
Photo 1 of 3 : UCIP_SP_2018_52125_67119.jpg

Overview looking east on right levee of Gold Run Creek (referred to Unit 2 of Cherokee Canal).

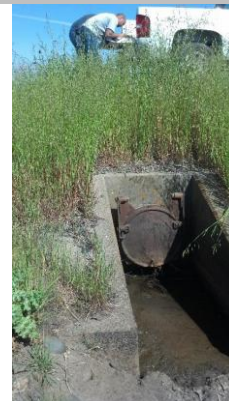
Photo 2 of 3 : UCIP_SP_2018_52125_67122.jpg

FS_ID:52125
DS_ID:16845
EP_NO: N/A
Repair Type: No Action Needed
Crossing Status: Found
UCIP Comments: 6/5/2017 LS Slide gate mostly underwater due to rice field being flooded but crossing appears to be in good condition. Pipe has been selected to be internally cleaned and inspected as part of the DMP project. (DWR Sutter Yard- A/Freitag)11/18/2016 Crossing appears to be in good condition. (DWR Sutter Yard- A/Freitag)4/27/2016 Crossing appears to be in good condition.7/01/2015 Crossing appears to be in good condition. No noticeable issues to report.5/29/2014 Same as last inspection.12/9/2013 Same as last inspection.7/10/2013 WS slope has been cleared of vegetation and is in good condition.4/19/2012 Limited inspection due to dense vegetation on WS slope. Need photos of clear WS slope.
FIELD_STRUCT_DESC: 24-inch corrugated metal drainage pipe through the levee, 5.6 feet below the crown. Flap gate on the waterside (WS) end. Slide gate on the landside (LS) end. Concrete "U" headwalls on both ends. [Additional Reference(s): DWR Levee Log, 1993. USACE Sacramento O&M Manual 519, June 1962 (HLM 4.69)]

Headwall and flap gate located on WS.

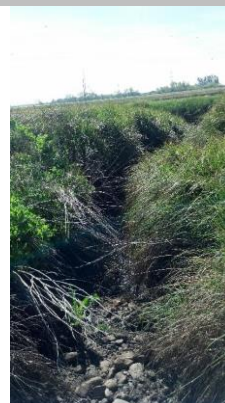
Photo 3 of 3 : UCIP_SP_2018_52125_67123.jpg

View of channel at crossing.

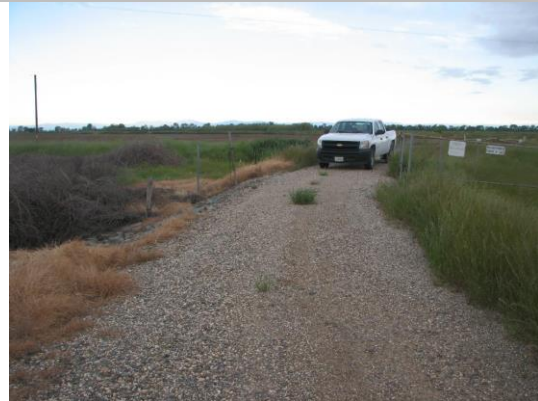
Photo 1 of 3 : UCIP_SP_2018_52126_67131.jpg

Overview looking west on the left levee of Cottonwood

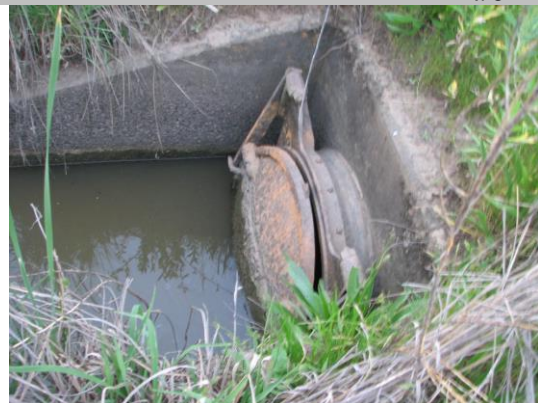
Photo 2 of 3 : UCIP_SP_2018_52126_67129.jpg

FS_ID:52126
DS_ID:16395
EP_NO: N/A
Repair Type: No Action Needed
Crossing Status: Found
UCIP Comments: 6/5/2017 WS mostly submerged but crossing appears to be in good condition.(DWR Sutter Yard- A/Freitag)11/18/2016 Crossing appears to be in good condition. Pipe is a 30" cmp. (DWR Sutter Yard- A/Freitag)4/27/2016 Crossing appears to be in good condition.6/30/2015 Erosion on LS does not appear to be getting any worse with the rip-rap there. WS pipe end and gate appeared in good condition.5/29/2014 Same as last inspection.12/9/2013 Same as last inspection.7/09/2013 Same as last inspection.4/19/2012 Rusted pipe debris located on WS. Remove pipe debris on WS and monitor the LS erosion near headwall. Rip-rap used to protect LS headwall from erosion. Was pipe exposed prior to dumping rock? Erosion on the LS could have exposed pipe. Dense shrub on the LS could restrict flow.
FIELD_STRUCT_DESC: 30-inch corrugated metal drainage pipe through the levee, 8.6 feet below the crown. Flap gate on the waterside (WS) end. Concrete "U" headwalls on both ends. [Additional Reference(s): DWR Levee Log, 1993. USACE Sacramento O&M Manual 519, June 1962 (HLM 5.06)]

Headwall and flap gate located on WS.

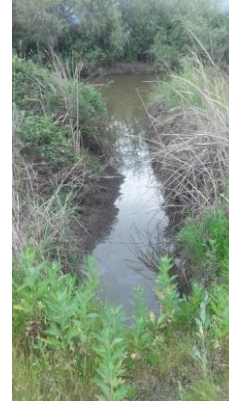
Photo 3 of 3 : UCIP_SP_2018_52126_67126.jpg

View of channel at crossing.

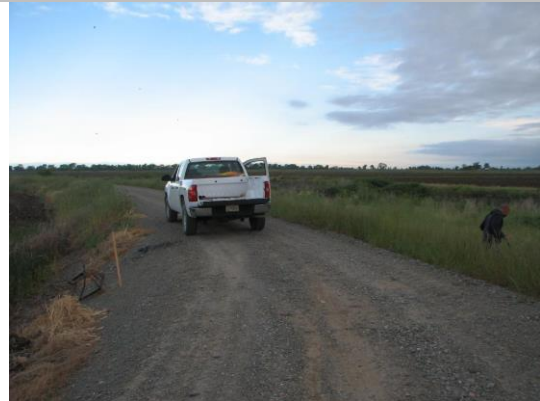
Photo 1 of 3 : UCIP_SP_2018_52129_67138.jpg

Overview of levee crown at crossing looking west.

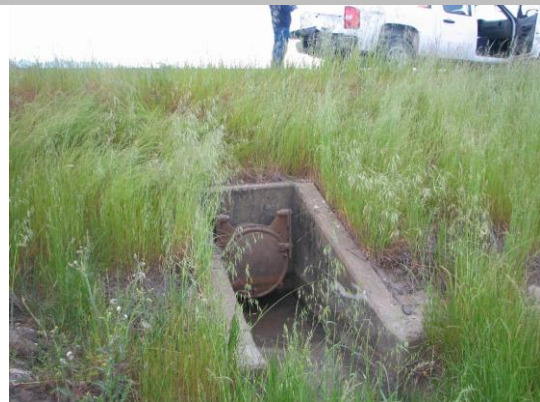
Photo 2 of 3 : UCIP_SP_2018_52129_67140.jpg

FS_ID:52129
DS_ID:16408
EP_NO: N/A
Repair Type: No Action Needed
Crossing Status: Found
UCIP Comments: 6/5/2017 Crossing appears to be in good condition. Pipe has been selected to be internally cleaned and inspected as part of the DMP project. (DWR Sutter Yard- A Freitag)11/18/2016 Crossing appears to be in good condition. (DWR Sutter Yard- A Freitag)4/27/2016 Crossing appears to be in good condition.6/30/2015 Crossing appears to be in good condition. No apparent issues to report.5/29/2014 Same as last inspection.12/9/2013 Same as last inspection.7/09/2013 WS and LS slopes have been cleared of vegetation and are in good condition. Slide gate on LS has been replaced.4/24/2012 Slide gate is damaged, needs to be replaced. Limited inspection on WS slope and toe due to dense vegetation. Need photos of clear WS slope and toe. This crossing was listed in the USACE Periodic Inspection report as Corp's inspection ID# USACE_CESPK_M13H_2011_p_0026 for broken gate on LS.

Headwall and flap gate located on WS.

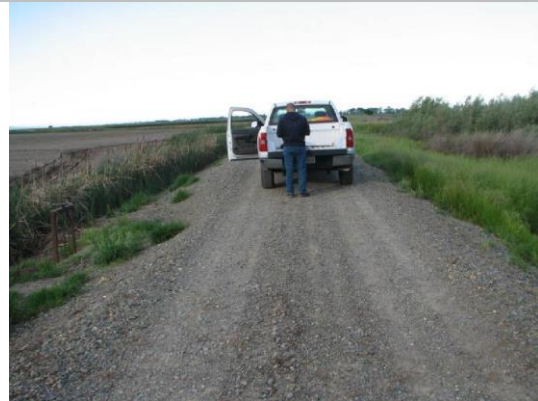
Photo 1 of 3 : UCIP_SP_2018_52130_67146.jpg

Overview of crossing looking downstream.

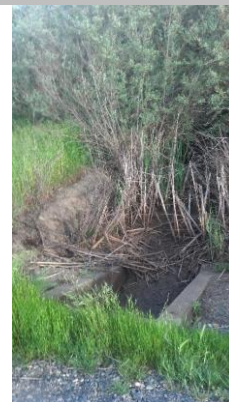
Photo 2 of 3 : UCIP_SP_2018_52130_67149.jpg

FS_ID:52130
DS_ID:16409
EP_NO: N/A
Repair Type: Non-Urgent
Crossing Status: Found
UCIP Comments: 6/5/2017 WS fully submerged and LS slide gate mostly buried by sediment. Pipe has been selected to be internally cleaned and inspected as part of the DMP project. (DWR Sutter Yard-AFreitag)11/18/2016 There is a flapgate on the WS and a slide gate on the LS. The LS slide gate appears to be partially buried and blocked by vegetation. (DWR Sutter Yard- AFreitag)4/27/2016 LS slide gate is blocked by vegetation. Pipe appears to not be used.6/30/2015 WS flap gate was still overgrown with vegetation. Needs to be cleared away.5/29/2014 Same as last inspection.12/9/2013 Same as last inspection.7/09/2013 Same as last inspection.4/24/2012 Limited inspection on WS slope due to dense vegetation. Need photo of clear WS slope during next inspection. This crossing was listed in the USACE Periodic Inspection report as Corp's inspect ID# USACE_CESPK_M13H_2011_p_0035 non-functional crossing due to overgrown vegetation on WS flap gate.

View of WS headwall with dense vegetation in channel.

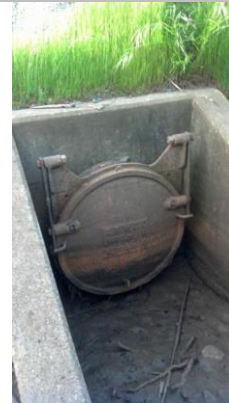
Photo 3 of 3 : UCIP_SP_2018_52130_67148.jpg

Headwall and flap gate located on WS.

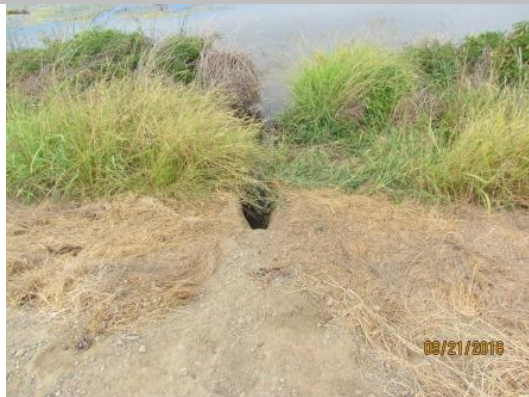
Photo 1 of 1 : SP_2018_MA0013_301_49_20180305_00011.jpg

LM Start	5.71	Rating **	M	Issue No.	49
LM End	5.71	Issue Type +	Ma	Location *	WS
Category	Earthen Levee			GPS Latitude/Longitude	
				Start	End
Item	Erosion / Bank Caving			39.523803 °	39.523803 °
				-121.699804 °	-121.699804 °
DWR ID	DWR_MA0013_02_f_2016_49				
Comment Code					
E2 : Schedule repair of erosion site prior to the next inspection.					
Inspector Comment					
1' by 2' by 4' hole in the levee toe that appears to be a temporary pump intake.

View of the man made hole at the waterside levee toe.

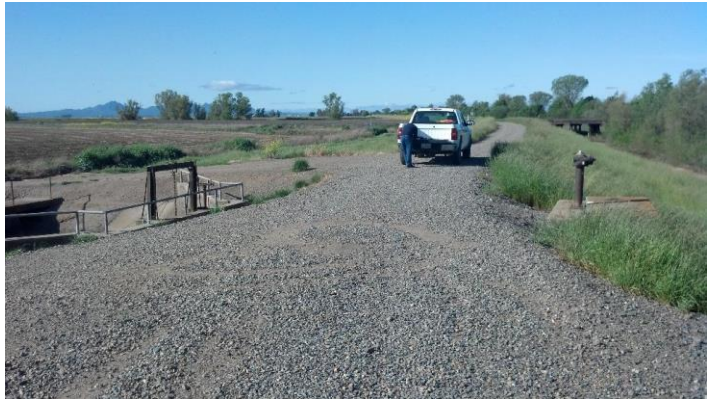
Photo 1 of 3 : UCIP_SP_2018_52145_67280.jpg

Overview of levee crown at crossing looking D/S.

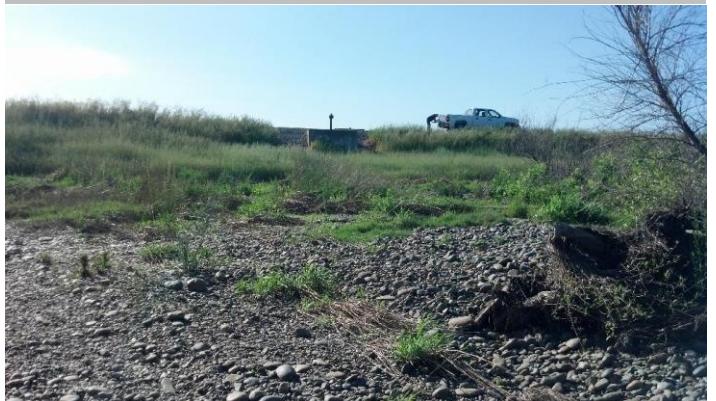
Photo 2 of 3 : UCIP_SP_2018_52145_67285.jpg

View of crossing looking from channel towards WS levee.

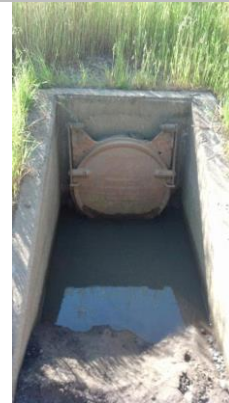
Photo 1 of 3 : UCIP_SP_2018_52146_67289.jpg

WS view of crossing. Dense vegetation along WS slope limited visual inspection. (WS Photo 1 of 2)

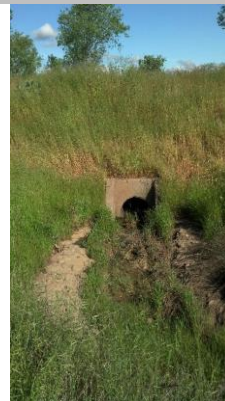
Photo 3 of 3 : UCIP_SP_2018_52146_67286.jpg

View of crossing from LS. Dense vegetation along LS slope limited visual inspection. (LS Photo 1 of 2)

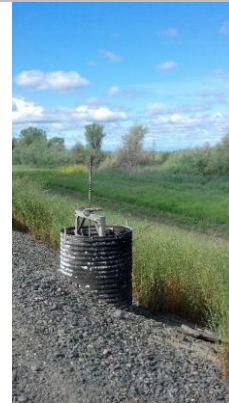
Photo 2 of 3 : UCIP_SP_2018_52154_67337.jpg

FS_ID:52154
DS_ID:16385
EP_NO: N/A
Repair Type: Non-Urgent
Crossing Status: Found
UCIP Comments: 5/30/2017 WS end cannot be located due to heavy vegetation. LS screwgate was mostly submerged during site visit. Pipe has been selected to be internally cleaned and inspected as part of the DMP project. (DWR Sutter Yard- A Freitag) 11/17/2016 WS still heavily vegetated and cannot access the WS pipe end for inspection. Vegetation needs to be cleared back. (DWR Sutter Yard- A Freitag) 4/26/2016 LS headwall was visible but gate was underwater. WS still heavily vegetated and unable to be inspected. Vegetation needs to be cleared back. 6/30/2015 WS heavily vegetated passed the toe-road and could not make it to the WS pipe end for inspection. Vegetation needs to be cleared back. LS pipe end was fully submerged under water. 5/28/2014 Same as last inspection. 12/4/2013 Same as last inspection. 7/08/2013 LS slope has been cleared of vegetation and is in good condition. LS headwall is now visible but mostly underwater so unable to do full inspection. WS is still vegetated. 4/24/2012 LS pipe & slide gate sedimented in. Limited inspection WS and LS slopes due to dense vegetation. Need photos of cleared WS and LS slopes during next inspection. This crossing was listed in the USACE Periodic Inspection report as Corp's inspect ID# USACE_CESPK_M13F_2011_p_0147 for limited visibility of LS and WS.

Stand pipe with screw gate WS

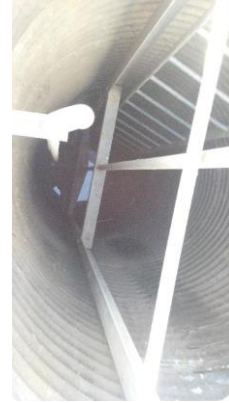
Photo 3 of 3 : UCIP_SP_2018_52154_67335.jpg

View of the inside of the WS stand pipe. No obstructions blocking slide gate.

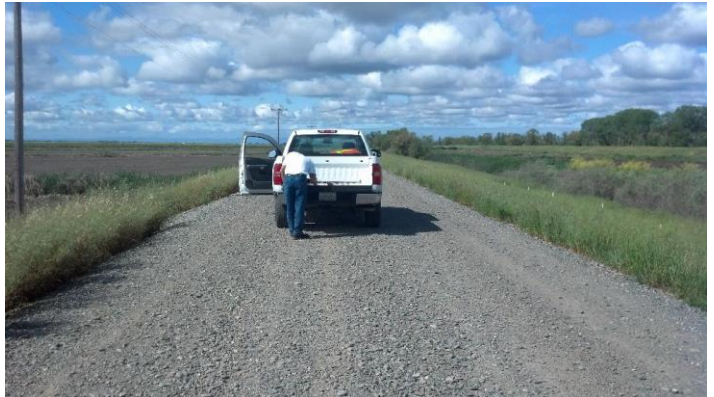
Photo 1 of 3 : UCIP_SP_2018_52156_67341.jpg

Overview of crossing looking downstream at the left bank of Cherokee Canal.

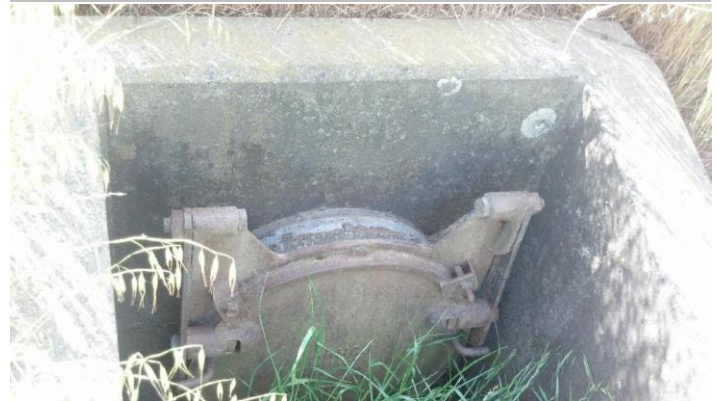
Photo 3 of 3 : UCIP_SP_2018_52156_67342.jpg

FS_ID:52156
DS_ID:16376
EP_NO: N/A
Repair Type: Non-Urgent
Crossing Status: Found
UCIP Comments: 5/30/2017 LS pipe end is buried and location unknown. WS flap gate is bolted shut. Pipe has been selected to be internally cleaned and inspected as part of the DMP project. (DWR Sutter Yard- A Freitag)11/17/2016 Unable to locate LS pipe end. WS flap gate bolted shut. (DWR Sutter Yard- A Freitag)4/26/2016 LS inlet appears to be buried as could not locate it. WS flap gate was bolted shut. This appears to be an abandoned crossing.6/30/2015 Still unable to locate the LS pipe end. 5/28/2014 Same as last inspection.12/4/2013 Same as last inspection. WS flapgate was bolted shut to keep LS ricefield flooded.7/08/2013 WS slope has been cleared of vegetation and is in good condition. LS slope also cleared of vegetation but still very dense on LS toe and unable to locate LS headwall.4/24/2012 Could not find LS end of pipe. Limited inspection on WS and LS slopes and toe due to dense vegetation. Need photos of cleared WS and LS slopes, and LS headwall during next inspection. This crossing was listed in the USACE Periodic Inspection report as Corp's inspect ID# USACE_CESPK_M13E_2011_p_0011 for WS gate blocked by vegetation.

View of WS headwall and flap gate.

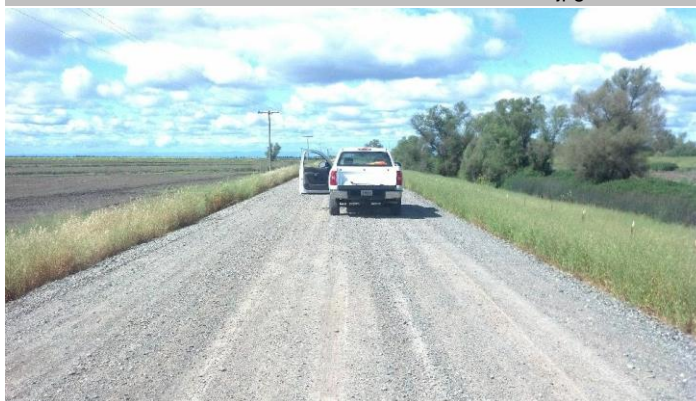
Photo 1 of 3 : UCIP_SP_2018_52157_67352.jpg

Overview of crossing looking downstream of the left bank of Cherokee

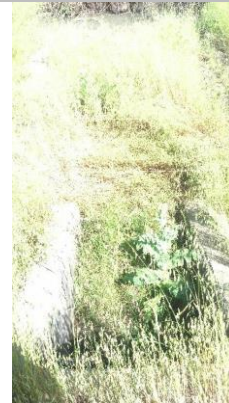
Photo 3 of 3 : UCIP_SP_2018_52157_67350.jpg

FIELD_STRUCT_DESC: *ABANDONED* 24-inch corrugated metal drainage pipe through the levee, 9 feet below the crown. Flap gate located on the waterside (WS) end. Concrete "U" headwalls on both WS and landside (LS). WS gate bolted shut and LS crossing is non-operable (inlet not found). Additional Reference(s): DWR Levee Log, 1993. USACE Sacramento O&M Manual 519, June 1962 (HLM 15.87)]
FS Date: 6/8/2017 9:26:40 AM

View of WS headwall.

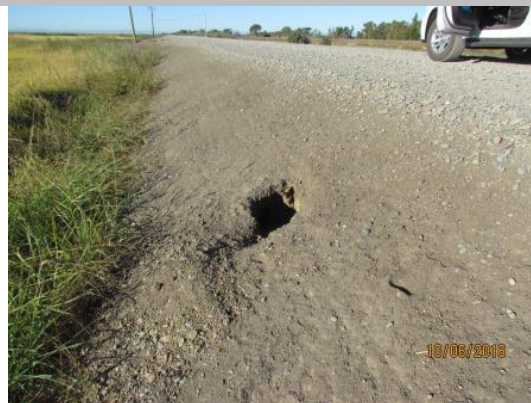
Photo 1 of 1 : SP_2018_MA0013_301_64_20180305_00017.jpg

LM Start	15.98	Rating **	U	Issue No.	64
LM End	15.98	Issue Type +	Ma	Location *	LS
Category	Earthen Levee			GPS Latitude/Longitude	
				Start	End
Item	Animal Control			39.414397 °	39.414397 °
				-121.781596 °	-121.781596 °
DWR ID	DWR_MA0013_02_f_2016_64				
Comment Code					
A3 : No rodents visible, but rodent burrows visible; need to backfill and compact or grout burrows.					
Inspector Comment

View of the rodent holes along the landside slope.

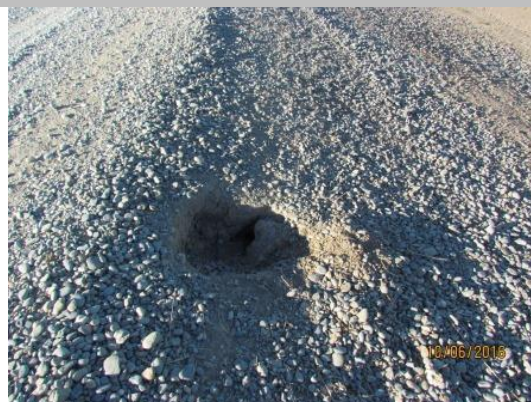
Photo 1 of 1 : SP_2018_MA0013_301_54_20180305_00014.jpg

LM Start	16.52	Rating **	U	Issue No.	54
LM End	16.52	Issue Type +	Ma	Location *	WS
Category	Earthen Levee			GPS Latitude/Longitude	
				Start	End
Item	Animal Control			39.409548 °	39.409548 °
				-121.789668 °	-121.789668 °
DWR ID	DWR_MA0013_02_f_2014_54				
Comment Code					
A3 : No rodents visible, but rodent burrows visible; need to backfill and compact or grout burrows.					
Inspector Comment

View of the rodent holes along the waterside slope.

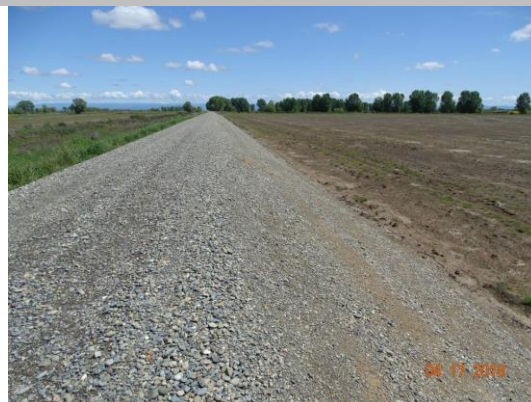
Photo 1 of 1 : SP_2018_MA0013_301_72_20180425_00142.jpg

LM Start	17.21	Rating **	A	Issue No.	72
LM End	22.17	Issue Type +	Ma	Location *	LS
Category	Earthen Levee			GPS Latitude/Longitude	
				Start	End
Item	Vegetation			39.403280 °	39.359625 °
				-121.799552 °	-121.872652 °
DWR ID	DWR_MA0013_02_s_2018_72				
Comment Code					
V1 : Control annual grass and weeds on the levee slopes and easements.					
Inspector Comment					
There is no vegetation along the landside slope.

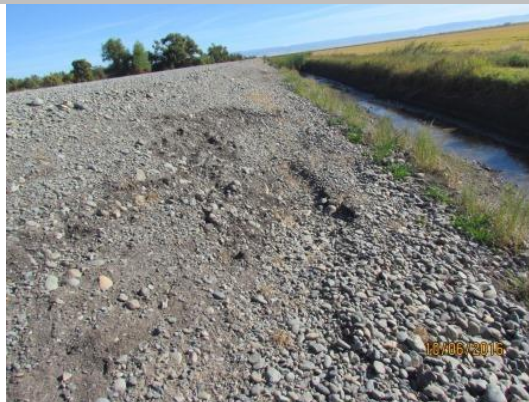
Photo 1 of 1 : SP_2018_MA0013_301_69_20180305_00018.jpg

LM Start	17.64	Rating **	M	Issue No.	69
LM End	17.64	Issue Type +	Ma	Location *	LS
Category	Earthen Levee			GPS Latitude/Longitude	
				Start	End
Item	Slope Stability			39.399164 °	39.399164 °
				-121.805787 °	-121.805787 °
DWR ID	DWR_MA0013_02_f_2016_69				
Comment Code					
S1 : Repair slope instability.					
Inspector Comment

View of slope instability issue along the landside slope.

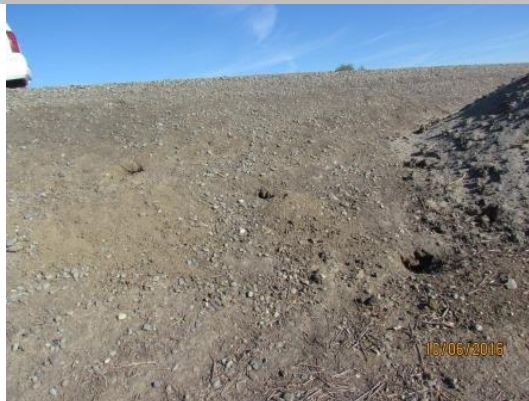
Photo 1 of 1 : SP_2018_MA0013_301_70_20180305_00019.jpg

LM Start	17.90	Rating **	M	Issue No.	70
LM End	17.90	Issue Type +	Ma	Location *	LS
Category	Earthen Levee			GPS Latitude/Longitude	
				Start	End
Item	Animal Control			39.396809 °	39.396809 °
				-121.809422 °	-121.809422 °
DWR ID	DWR_MA0013_02_f_2016_70				
Comment Code					
A3 : No rodents visible, but rodent burrows visible; need to backfill and compact or grout burrows.					
Inspector Comment

View of the rodent holes along the landside slope.

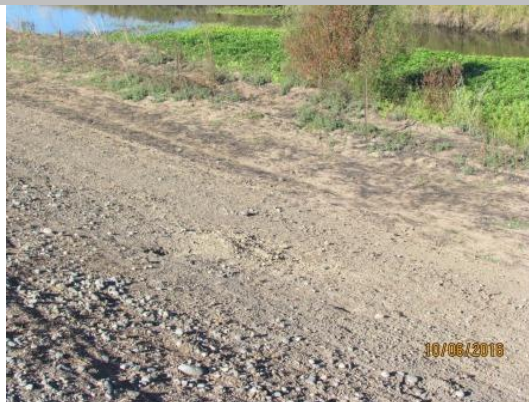
Photo 1 of 1 : SP_2018_MA0013_301_71_20180305_00020.jpg

LM Start	17.93	Rating **	M	Issue No.	71
LM End	17.93	Issue Type +	Ma	Location *	LS
Category	Earthen Levee			GPS Latitude/Longitude	
				Start	End
Item	Animal Control			39.396465 °	39.396465 °
				-121.809935 °	-121.809935 °
DWR ID	DWR_MA0013_02_f_2016_71				
Comment Code					
A3 : No rodents visible, but rodent burrows visible; need to backfill and compact or grout burrows.					
Inspector Comment

View of the rodent holes along the landside slope.

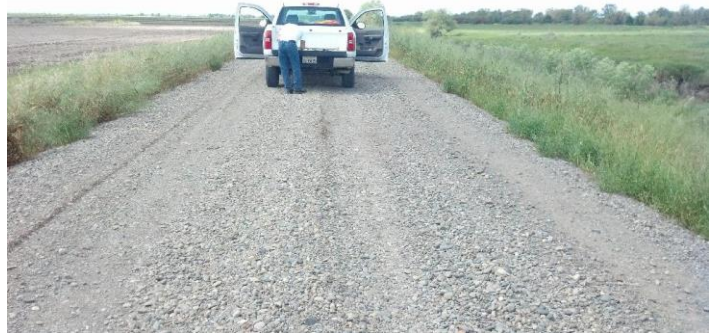
Photo 1 of 3 : UCIP_SP_2018_52161_67387.jpg

FS_ID:52161
DS_ID:16379
EP_NO: N/A
Repair Type: No Action Needed
Crossing Status: Found
UCIP Comments: 5/30/2017 Crossing appears to be in good condition. Pipe has been selected to be internally cleaned and inspected as part of the DMP project. (DWR Sutter Yard- AFreitag)11/17/2016 Crossing appears to be in good condition. (DWR Sutter Yard- AFreitag)4/26/2016 Crossing appears to be in good condition.6/30/2015 Vegetation still present on WS. LS side was underwater during inspection.5/28/2014 Same as last inspection.12/4/2013 Same as last inspection.7/08/2013 LS slope cleared of vegetation and is in good condition. WS is still vegetated. LS pipe end under water and blocked off by plywood so unable to measure culvert size.4/24/2012 Limited inspection on WS and LS slopes due to dense vegetation. Need photos of cleared WS and LS slopes. This crossing was listed in the USACE Periodic Inspection report as Corp's inspect ID# USACE_CESPK_M13E_2011_p_0134 for unknown culvert size on LS and no outlet visible on WS.

Overview of crossing looking D/S at left bank of Cherokee Canal.

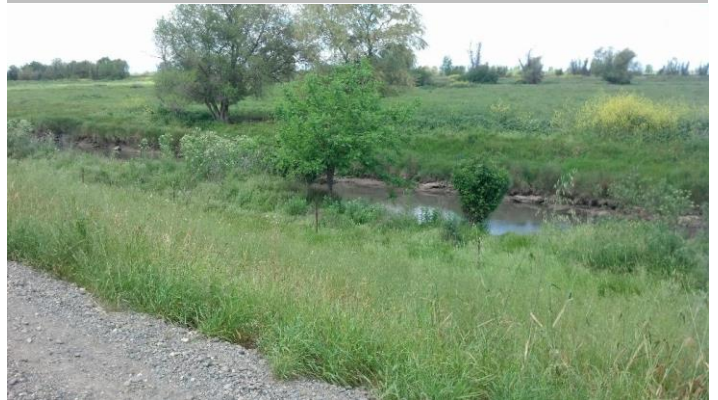
Photo 2 of 3 : UCIP_SP_2018_52161_67386.jpg

View of WS slope and berm.

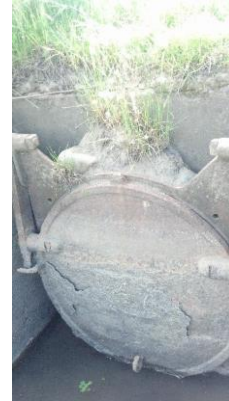
Photo 3 of 3 : UCIP_SP_2018_52161_67390.jpg

View of flap gate located on WS.

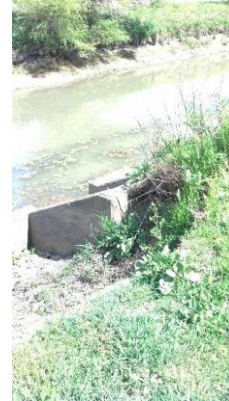
Photo 1 of 3 : UCIP_SP_2018_52164_67401.jpg

FS_ID:52164
DS_ID:16375
EP_NO: N/A
Repair Type: Non-Urgent
Crossing Status: Found
UCIP Comments: 5/30/2017 Erosion still present at WS headwall. Pipe has been selected to be internally cleaned and inspected as part of the DMP project. (DWR Sutter Yard- AFreitag)11/17/2016 Erosion still present at WS headwall. (DWR Sutter Yard- AFreitag)4/26/2016 Erosion still present behind the WS headwall. The rest of the crossing appears in good condition.6/30/2015 Erosion still present behind the WS headwall. Everything thing else with the crossing appeared to be in good condition.12/4/2013 Same as last inspection.5/28/2014 Same as last inspection.7/08/2013 Erosion problem same as last inspection. WS and LS slopes have been cleared of vegetation and are in good shape.4/24/2012 Erosion present behind WS headwall. Limited inspection on WS and LS slopes due to dense vegetation. Need photos of cleared WS and LS slopes during next inspection.

Erosion behind WS headwall looking at the downstream edge of headwall.

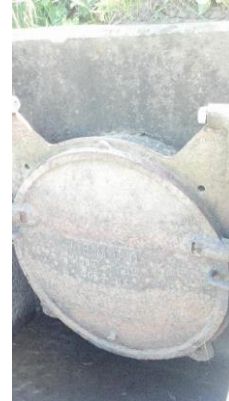
Photo 3 of 3 : UCIP_SP_2018_52164_67402.jpg

Flap gate located on the WS.

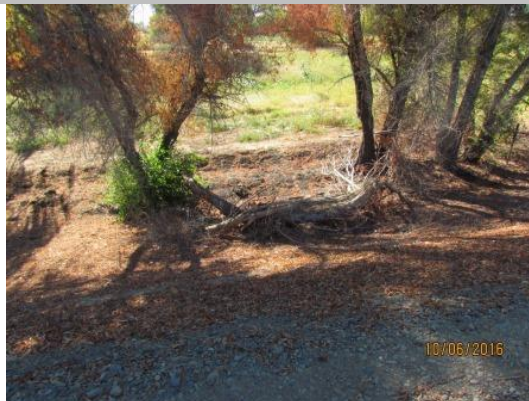
Photo 1 of 1 : SP_2018_MA0013_301_73_20180305_00021.jpg

LM Start	20.52	Rating **	M	Issue No.	73
LM End	20.52	Issue Type +	Ma	Location *	LS
Category	Earthen Levee			GPS Latitude/Longitude	
				Start	End
Item	Encroachments			39.372486 °	39.372486 °
				-121.846537 °	-121.846537 °
DWR ID	DWR_MA0013_02_f_2016_73				
Comment Code					
TR : Tree or limb					
Inspector Comment					
Remove the tree limbs from the landside slope and toe.

View of the tree limbs along the landside levee toe.

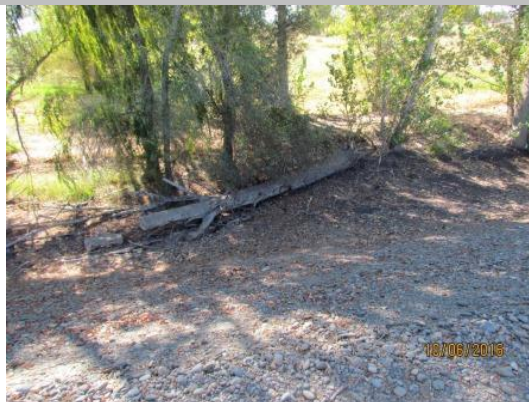
Photo 1 of 1 : SP_2018_MA0013_301_52_20180305_00012.jpg

LM Start	20.65	Rating **	M	Issue No.	52
LM End	20.65	Issue Type +	Ma	Location *	LS
Category	Earthen Levee			GPS Latitude/Longitude	
				Start	End
Item	Encroachments			39.371433 °	39.371433 °
				-121.848753 °	-121.848753 °
DWR ID	DWR_MA0013_02_s_2014_52				
Comment Code					
TR : Tree or limb					
Inspector Comment					
Remove the tree limbs from the landside slope and toe.

View of the tree limbs along the landside toe.

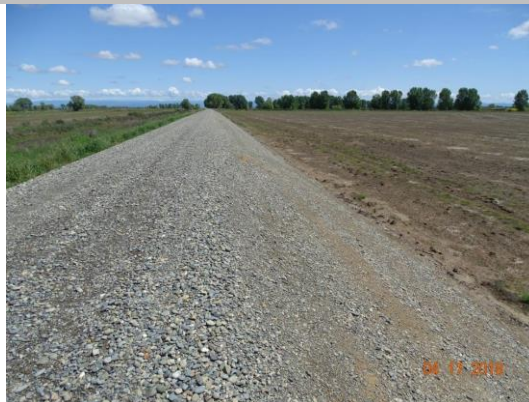
Photo 1 of 1 : SP_2018_MA0013_301_68_20180425_00140.jpg

LM Start	21.03	Rating **	M	Issue No.	68
LM End	21.03	Issue Type +	Ma	Location *	LS
Category	Earthen Levee			GPS Latitude/Longitude	
				Start	End
Item	Animal Control			39.368682 °	39.368682 °
				-121.854817 °	-121.854817 °
DWR ID	DWR_MA0013_02_s_2018_68				
Comment Code					
A1 : Exterminate rodents and backfill and compact or grout burrows.					
Inspector Comment					
Repair the rodent holes along the landside slope.

View of the rodent holes along the landside slope.

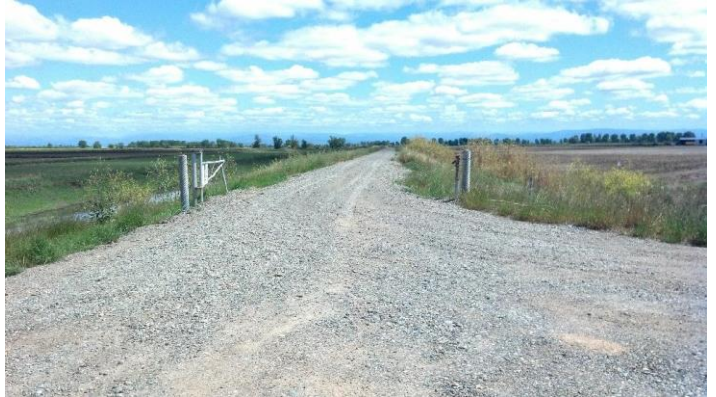
Photo 1 of 3 : UCIP_SP_2018_52170_67462.jpg

FS_ID:52170
DS_ID:16394
EP_NO: N/A
Repair Type: Non-Urgent
Crossing Status: Found
UCIP Comments: 5/30/2017 WS flap gate showing signs of rusting and deterioration but still appears to be able to function properly. Pipe has been selected to be internally cleaned and inspected as part of the DMP project. (DWR Sutter Yard - A Freitag) 11/17/2016 WS flap gate is really rusted and deteriorated but it appears to still function properly. (DWR Sutter Yard - A Freitag) 4/26/2016 WS flap gate is really rusted and deteriorated. May need to be replaced. The rest of the crossing appeared in good condition. 6/30/2015 Crossing is in good condition. No noticeable issues to be reported. 5/28/2014 Same as last inspection. 12/4/2013 WS and LS slopes are in good condition. 7/08/2013 Same as last inspection. 4/24/2012 Limited inspection on WS and LS slopes due to dense vegetation. Need photos of cleared WS and LS slopes. This crossing was listed in the USACE Periodic Inspection report as Corp's inspect ID# USACE_CESPK_M13E_2011_p_0251 for no outlet visible on WS. FIELD_STRUCT_DESC: 24-inch corrugated metal drainage pipe through the levee, 11.6 feet below the crown. Flap gate on the waterside (WS) end. Concrete "U" headwalls on both WS and landside (LS). Rusted gate located on the WS (gate stuck). [Additional Reference(s): DWR Levee Log, 1993. USACE Sacramento O&M Manual 519, June 1962 (HLM 22.08)]

Overview of crossing looking upstream at the left bank of Cherokee Canal.

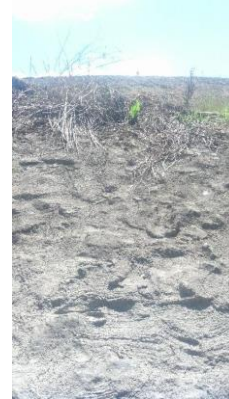
Photo 1 of 3 : UCIP_SP_2018_52175_67498.jpg

FS_ID:52175
DS_ID:16391
EP_NO: N/A
Repair Type: Non-Urgent
Crossing Status: Found
UCIP Comments: 5/30/2017 Location of LS inlet still unknown. Need to trace with utility locator/GPR to find. Pipe has been selected to be internally cleaned and inspected as part of the DMP project. (DWR Sutter Yard - A Freitag) 11/17/2016 Unable to locate LS pipe end. Ws appears to be in good condition. (DWR Sutter Yard - A Freitag) 4/26/2016 Still unable to locate the LS headwall and end of pipe. Pipe is still being used. Pipe was draining to WS. 6/30/2015 Still unable to locate the LS headwall and pipe end. 5/28/2014 Same as last inspection. 12/4/2013 Same as last inspection. 7/08/2013 Same as last inspection. Unable to locate LS headwall. 4/24/2012 Unable to locate LS headwall. Need photo of LS headwall during next inspection. FIELD_STRUCT_DESC: 30-inch corrugated metal drainage pipe through the levee, 15.3 feet below the crown. Concrete "U" headwalls on both waterside (WS) and landside (LS) ends. Flap gate on the WS end. This pipe runs on an angle through the levee, then underground along the LS slope to historic levee mile (HLM) 22.39 where it enters a ditch on the LS. [Additional Reference(s): DWR Levee Log, 1993. USACE Sacramento O&M Manual 519, June 1962 (HLM 22.41)]

View of WS slope looking from WS headwall to levee crown.

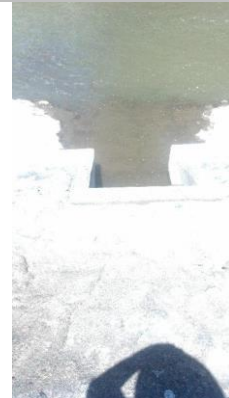
Photo 2 of 3 : UCIP_SP_2018_52175_67496.jpg

View of WS slope looking from WS headwall to levee crown.

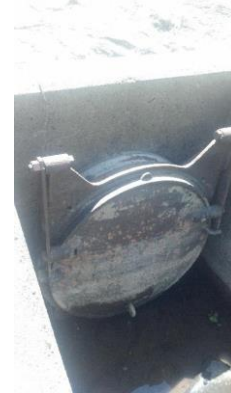
Photo 3 of 3 : UCIP_SP_2018_52175_67497.jpg

View of flap gate on WS.
